# Inspector's Daily Report

IDR Sheet	1	of	1	Sheets	Final Record Book	Page
Contract	C-7852			Day	Tuesday	
				Date	September 28, 2010

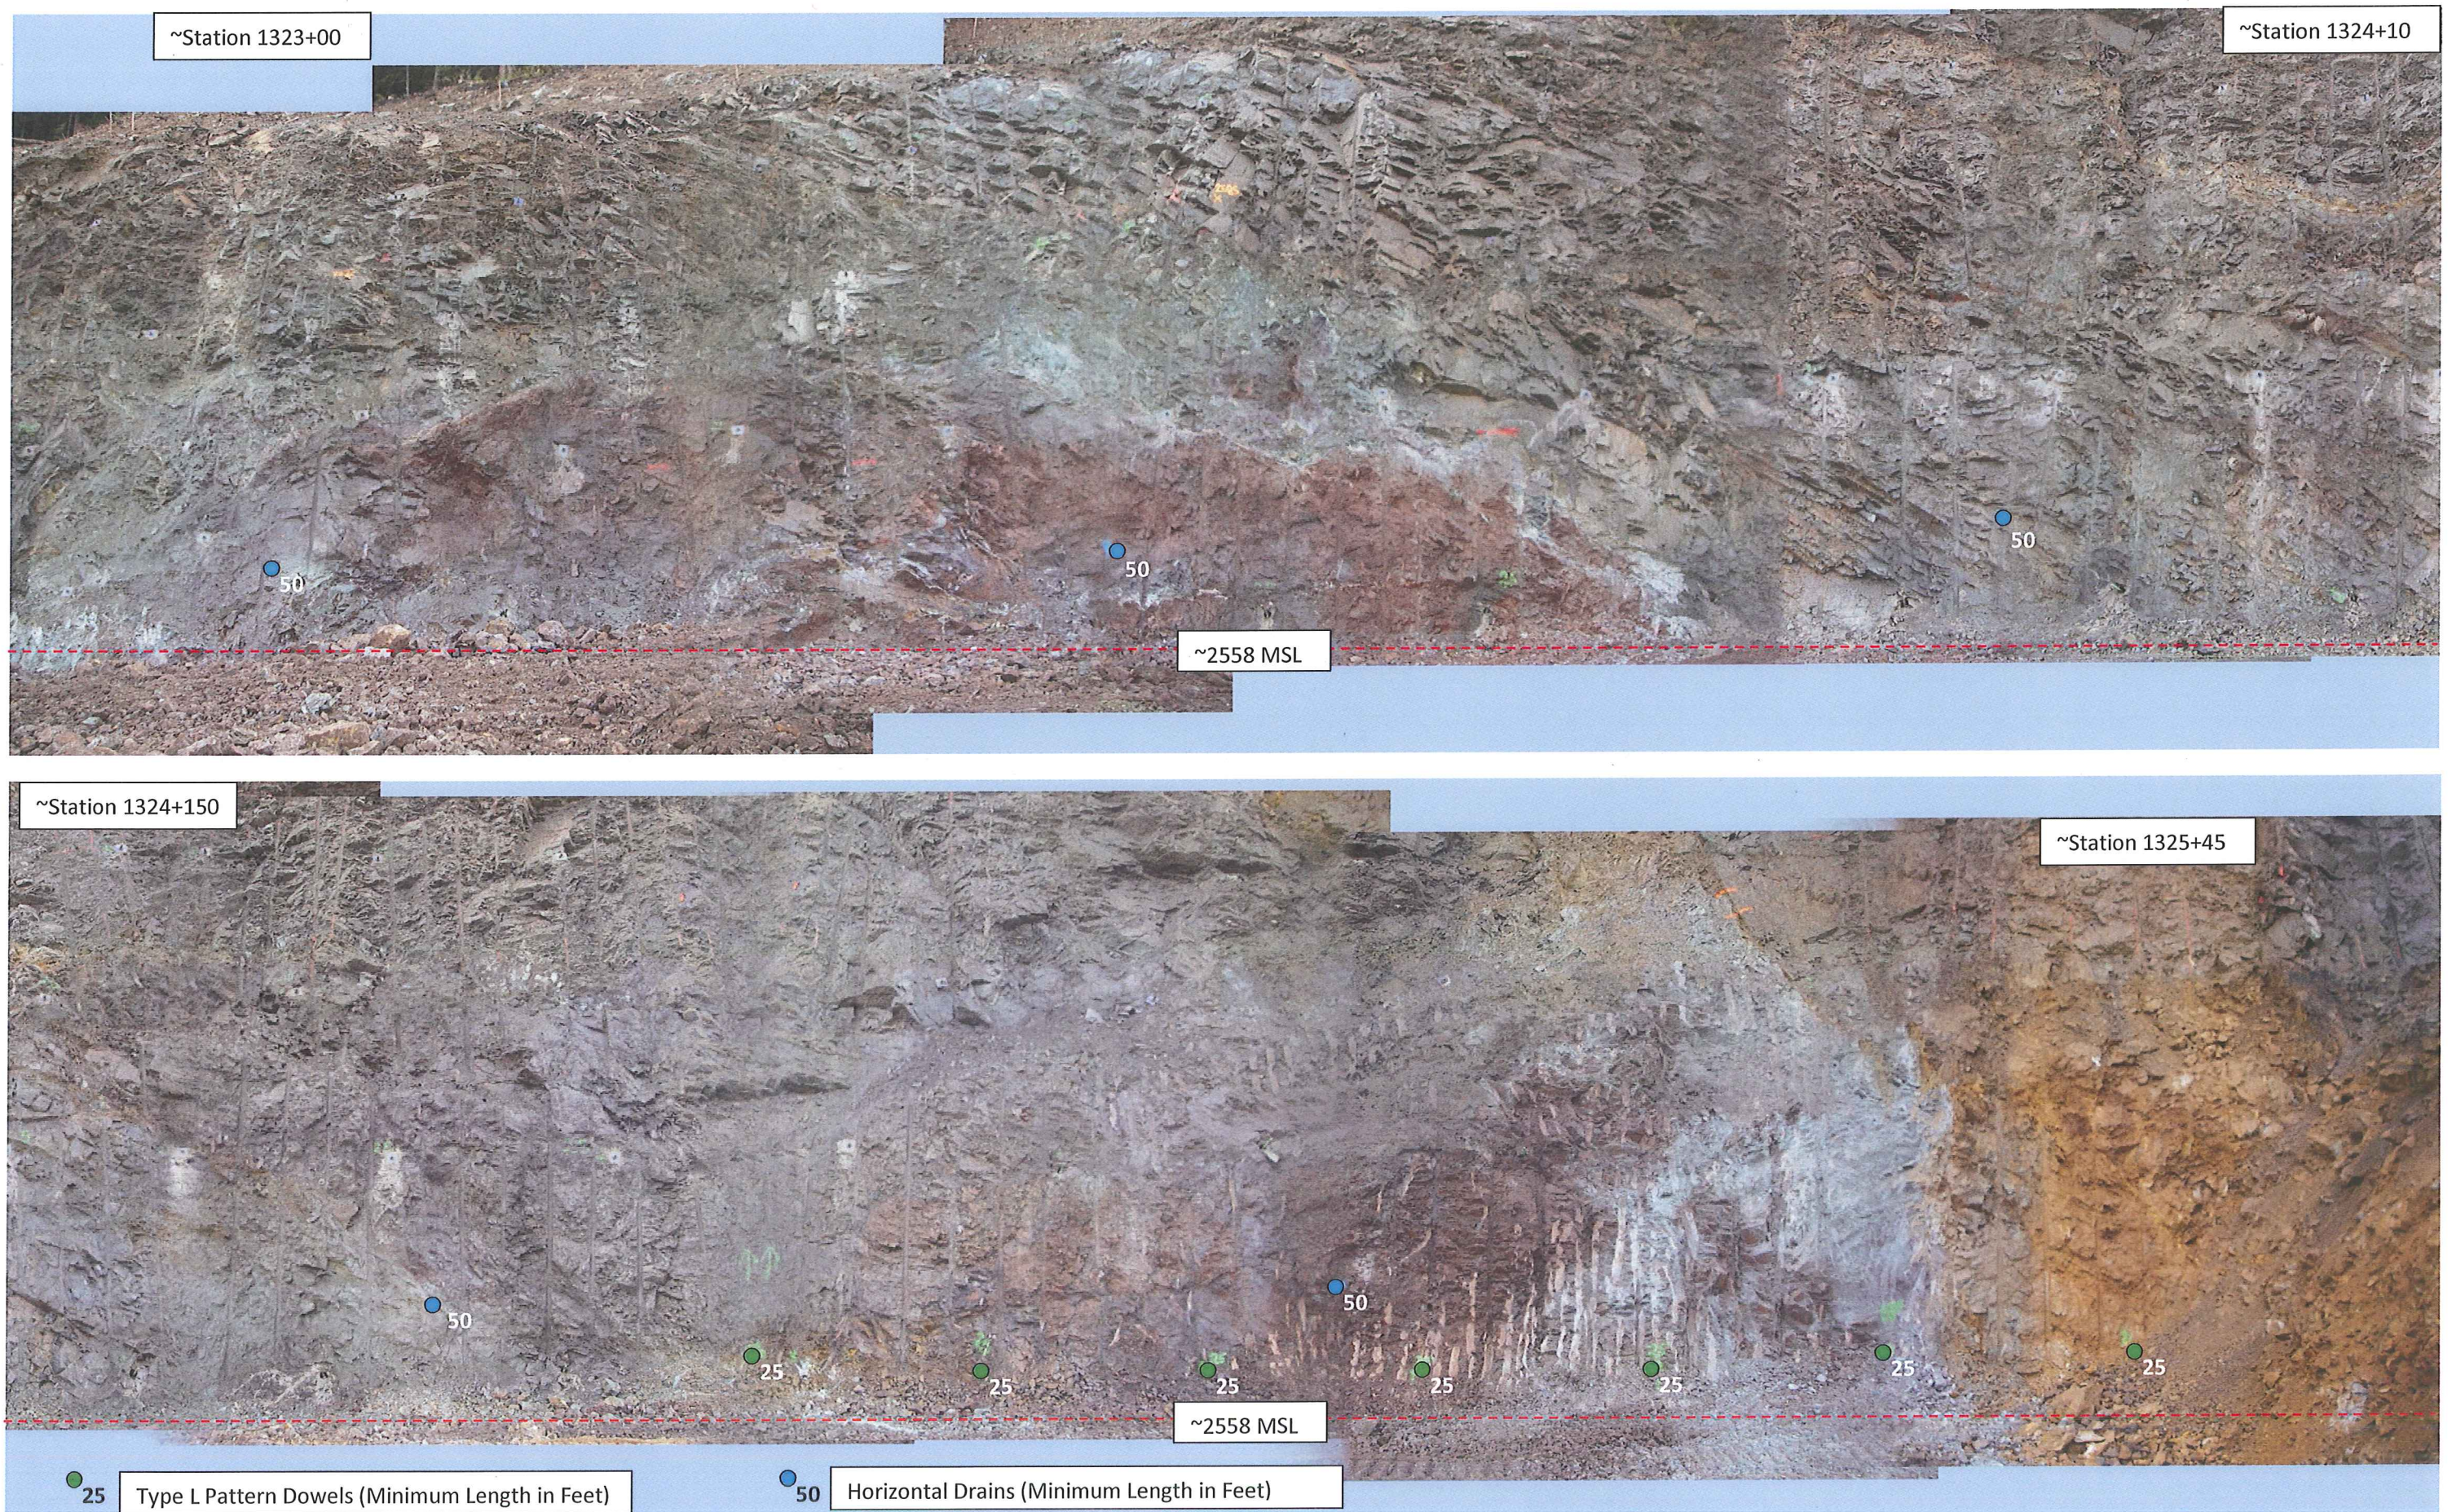
Brad, Rocki Bishop, and I located 5 horizontal drains and 7 pattern dowels from approximate station 1323+00 to 1325+45 to approximate elevation 2558 MSL (Figure 1). We also located 3 spot dowels around station 1339+40 to approximate elevation 2535 MSL (Figure 2).

Figure 1. A photograph showing the lift inspection from approximate station 1323+00 to 1325+45 to approximate elevation 2558 MSL.

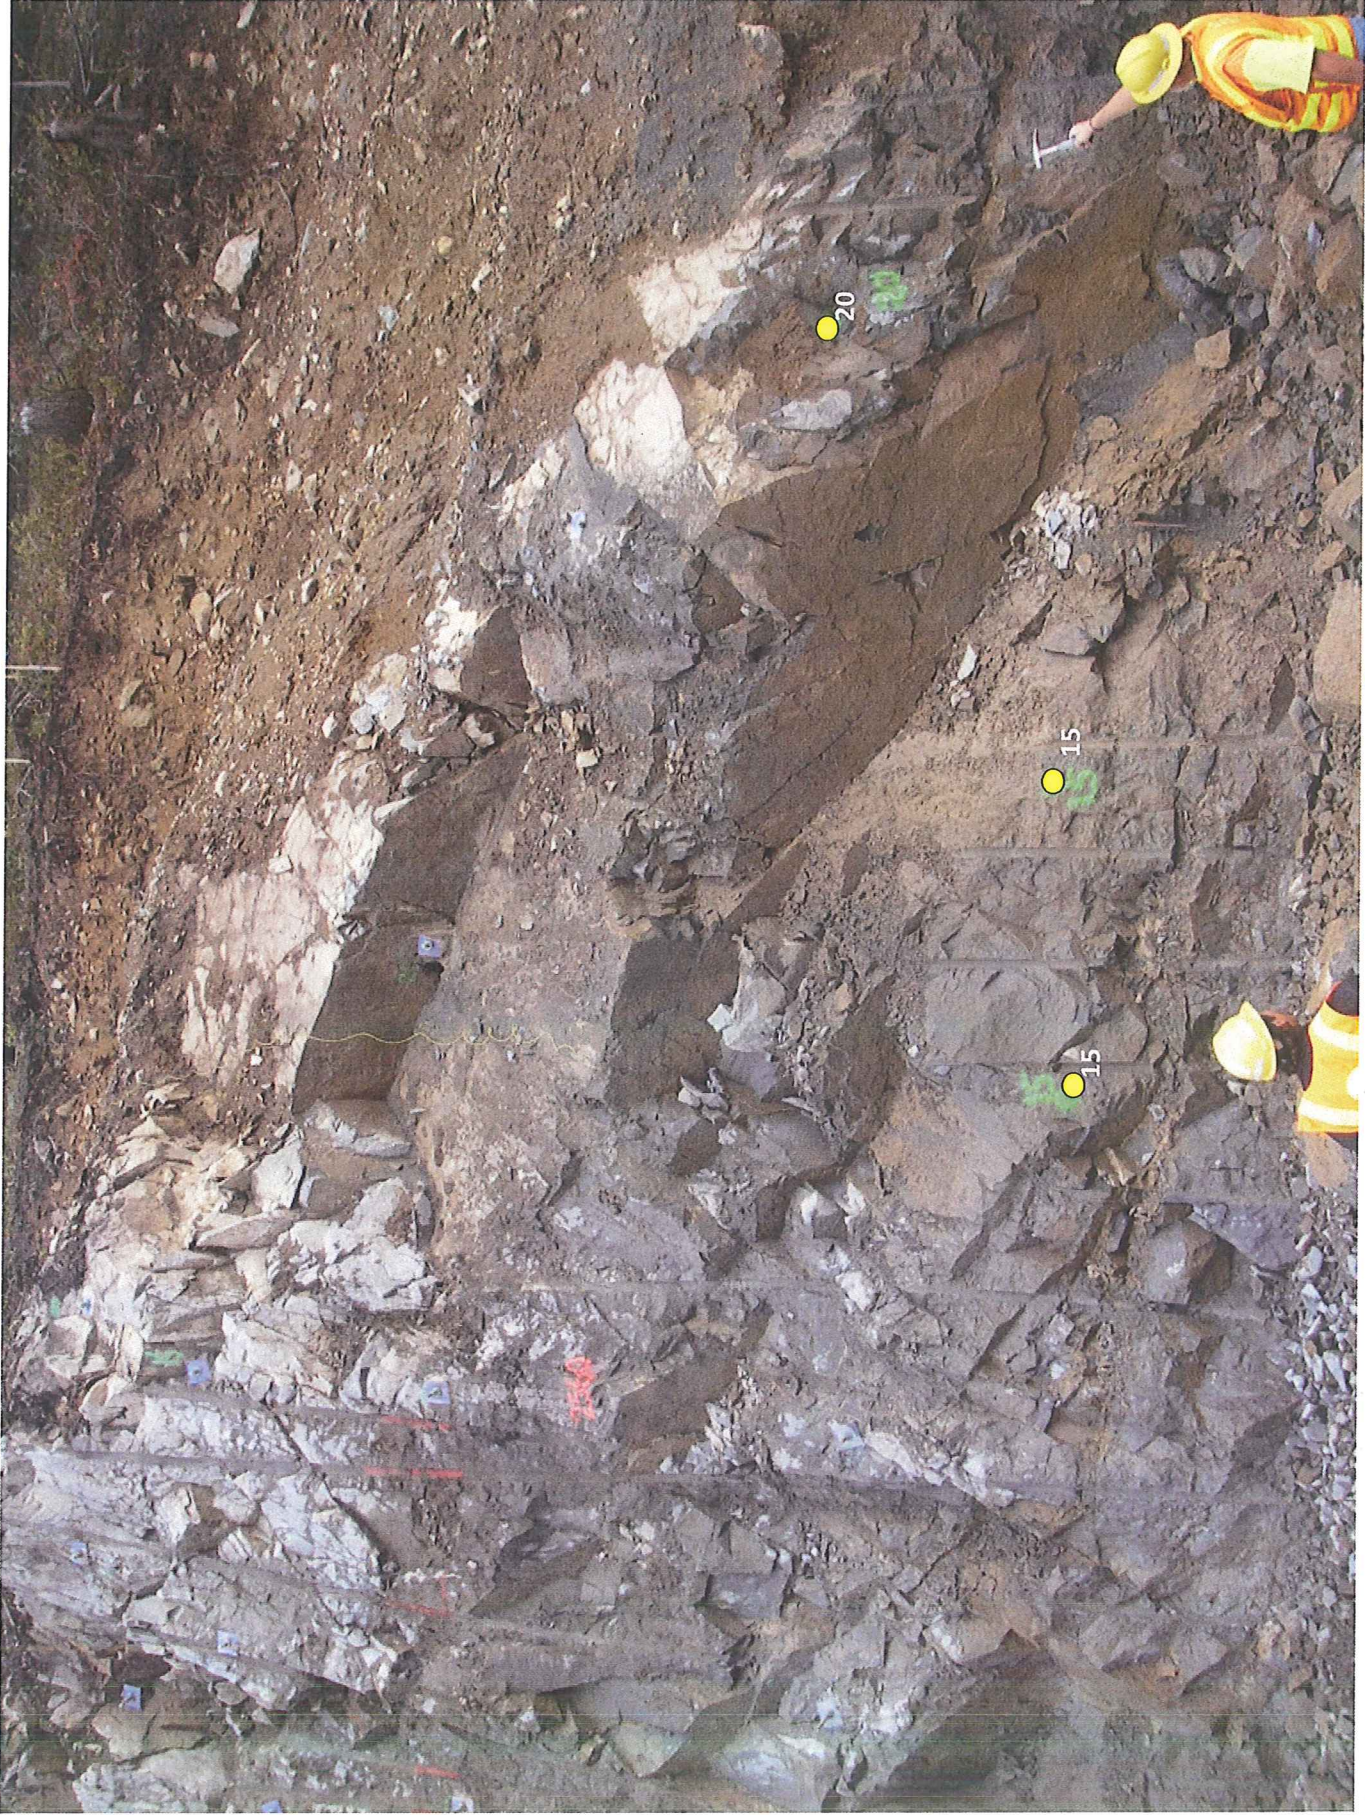
Figure 2. A photograph showing 3 spot dowels located at approximate station 1339+40. 20 Type L Spot Dowel (Minimum Length in Feet)
